ESL-TR-92-53

EXPANDED POLYSTYRENE PROTECTIVE BARRICADE FULL-SCALE FIRE EXPOSURE TEST

J.H. STORM, B.R. DEES, M.J. WILSON

APPLIED RESEARCH ASSOCIATES, INC. 4300 SAN MATEO BLVD., N.E. SUITE A220 ALBUQUERQUE NM 87110

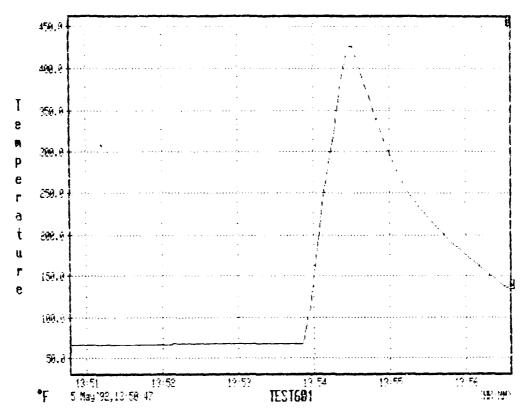
Figure 4. Paint Spill Test - Thermocouple #1, Adjacent to Fire

The paint spill test was conducted as described in Section II. Four ounces of lacquer touch-up paint was poured on the floor in the corner of the polystyrene cell, as shown in Figures 1 and 2. After a 10-second period to permit the paint to spread, the paint was ignited with a butane lighter. This lacquer paint ignited readily from the gas lighter but would not light from a spark ignition source alone. During paint ignition tests, conducted previously, this type lacquer did ignite readily from a spark ignition source alone (no flame). The paint burned for 3 minutes and 30 seconds and self extinguished. Damage the polystyrene walls was minimal. The surface of the polystyrene was melted and scorched, but did not melt through or release any sand. The polystyrene material itself did not burn or contribute to the fire.

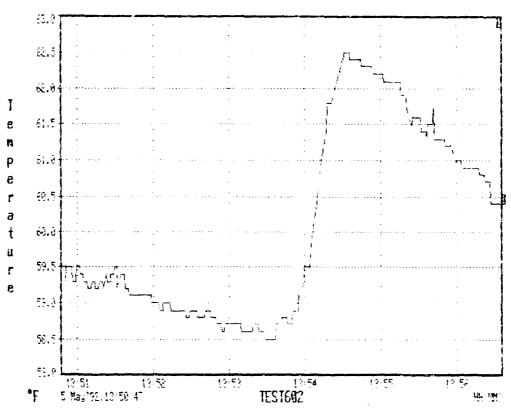
Figure 5. Paint Spill Test - Thermocouple #2, Cell Left Wall

Thermocouples were located and numbered as shown in Figure 2. As can be seen by the temperature measurements shown in Figures 4 through 9, ignition occurred at approximately 1354. Thermocouple number 1 was located on the back wall of the polystyrene cell just behind the paint fire. Peak temperature at this location was 425°F. The peak temperature at location 5, the position where a weapon might be located, was 83°F.

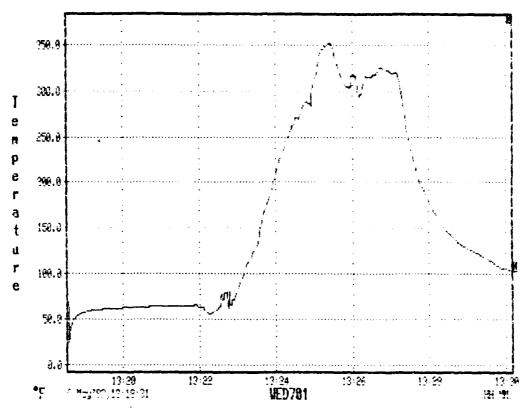
Figure 10. Unprotected Barricade Test - Thermocouple #1, Adjacent to Fire

The fire was ignited at 1323 with a butane lighter. The intensity of the fire built slowly at first and later into a fully developed wood fire. The polystyrene began melting from the walls in the area of the fire approximately 80 seconds after ignition. In 4 minutes the polystyrene wall broke releasing sand onto the fire, partially extinguishing it. Approximately 5 minutes after ignition, a large quantity of sand flowed from the wall, extinguishing the fire. At no time did the melted polystyrene burn or contribute to the fire.

The volume of sand released from the failed polystyrene wall structure was approximately 2.9 feet³. Depleted areas of the wall were limited to 24 inches from the inside corner in the top half of the wall sections.

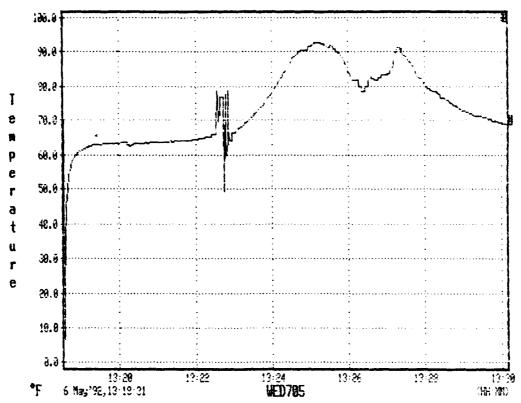
Figure 14. Unprotected Barricade Test - Thermocouple #5, Center of Cell, 3 Ft

Temperature profiles are shown in Figures 10 through 15. Thermocouple numbers and locations are shown in Figure 2. Thermocouple number 1, located on the polystyrene wall adjacent to the fire recorded the highest temperature at 350°F. The peak temperature at location 5, the position where a weapon might be located, was 92°F.

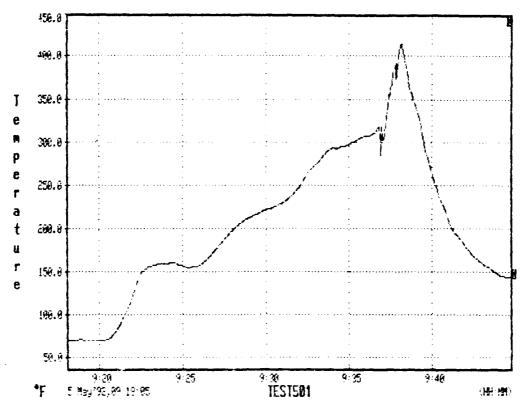
Figure 16. Covered Barricade Test - Thermocouple #1, Adjacent to Fire

The fire was ignited at 0921 with a butane lighter. The paper on the dry wall began to burn at approximately 0924. At approximately 0936, 15 minutes after the fire was ignited, the dry wall broke out at the lower section of the wall adjacent to the fire, releasing some sand on the edge of the burning wood crib. A post fire examination showed that some of the nylon straps that hold the polystyrene walls together had melted. The loss of internal structural integrity resulte in the weight of the sand breaking through the polystyrene and now deteriorated dry wall. The wood crib fire continued to burn for an additional 4 minutes before it was extinguished using C_6 fire extinguishing agent. Some polystyrene melted during the fire but did not burn or contribute to the fire.

Temperature profiles are shown in Figures 16 through 21. Thermocouple numbers and locations are shown in Figure 2. Thermocouple number 1 was located on the polystyrene wall behind the sheet rock protective covering. As a result, the temperature at this location rose slowly until the sheet rock broke, exposing the sensor directly to the fire. Peak temperature at this location was approximately 425°F. The peak temperature at location 5, the position where a weapon might be located, was 162°F. This temperature was somewhat higher than in the unprotected crib fire test. This higher temperature was due to the longer burning time, and consequently larger, more developed fire, during this test as compared to the unprotected fire. Reflected radiant heat from the sheet rock may also have contributed to this higher temperature at the weapon location. The high temperatures indicated by thermocouples 3 and 4, Figures 18 and 19, appear to be instrumentation anomalies.
